Research Report for the 2018 Archaeological Studies at San Dionisios (GHPI site 66-02-1024) and Palasyo (GHPI Site 66-02-1116), Humatak, Guam

Abstract

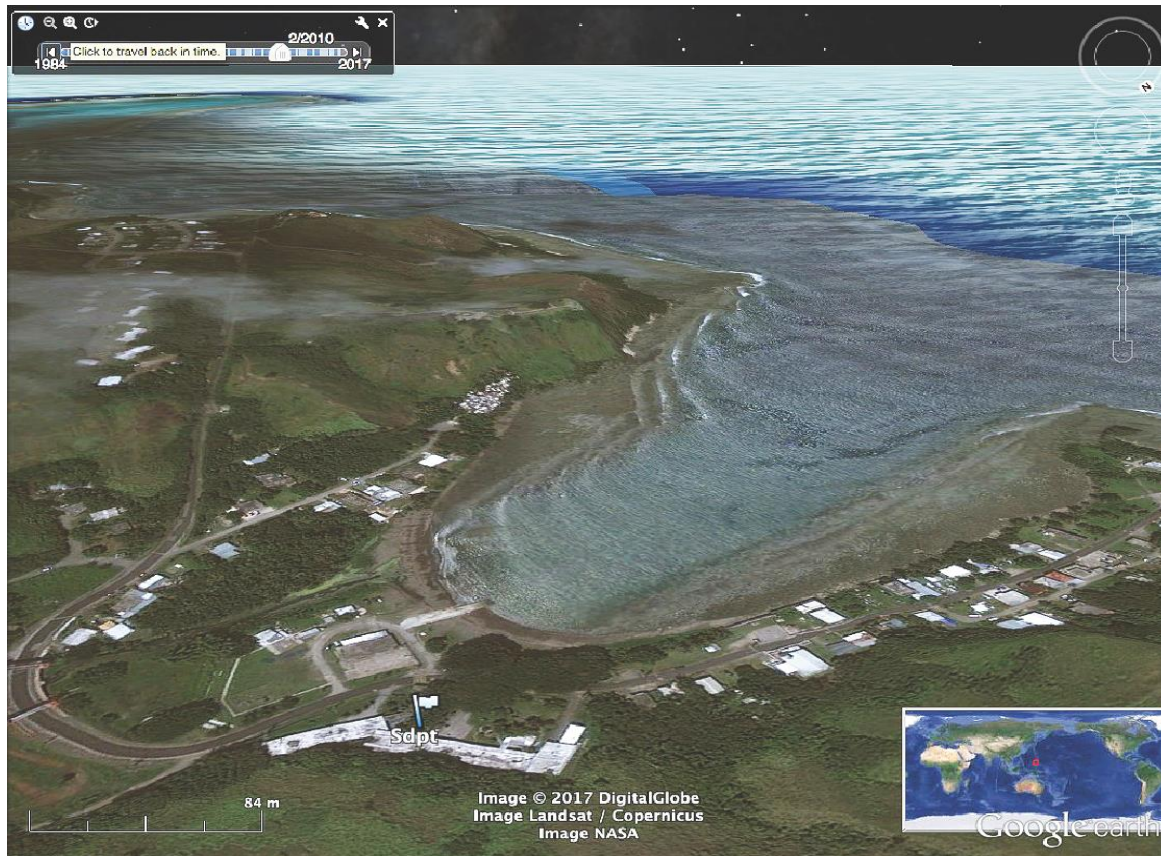
Figure 1. Umatac Bay and San Dionisios. Courtesy of Richard Schaefer y Cardno GS Inc.

In 2018 (April 24-May 25), we conducted the second archaeological field season at Humatak (figure 1) within the framework of the ABERIGUA project. *Archeology of Iberian colonialism in Guam and the Marianas Islands (Western Pacific)*. The archaeological field research focused on the preserved remnants the church of San Dionisio Areopagita and its associated cemetery (figure 2), as well as remains of the Palasyo site that once served as a governor's palace. The major aim of the study was to understand processes of identity, change, and continuity that related to Spanish colonialism on the native population (i.e., Chamorro) in the Mariana Islands (see Bayman and Peterson 2016).

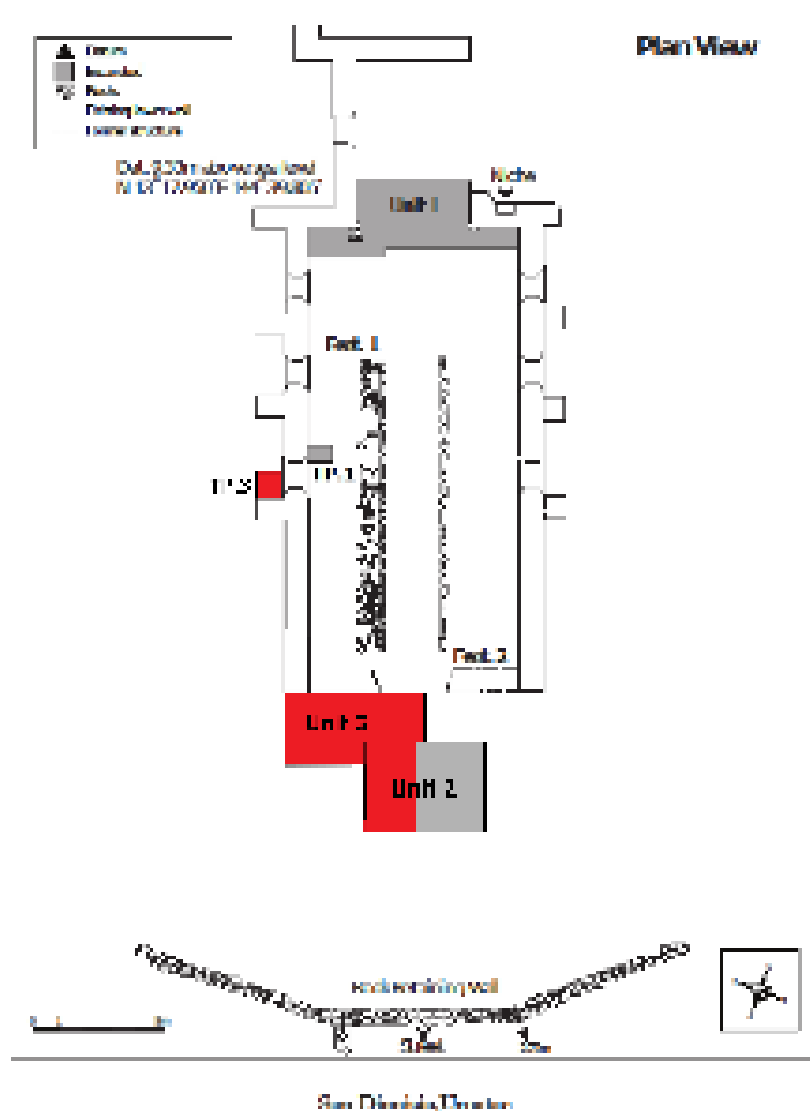
Figure 2. Plan view San Dionisio with 2017 excavations (grey) and 2018 excavations (red). Courtesy of Richard Schaefer y Cardno GS Inc.

Unit 2 was first opened in 2017 (figure 2). In 2018, we expanded it to the west. We have not yet reached the sterile layer since we encountered burials that require detailed documentation. Such documentation is a necessary but time-consuming effort. Thus far, we have documented 4 layers, a construction unit, three burials and four clusters of bones that may (or may not) be burials.

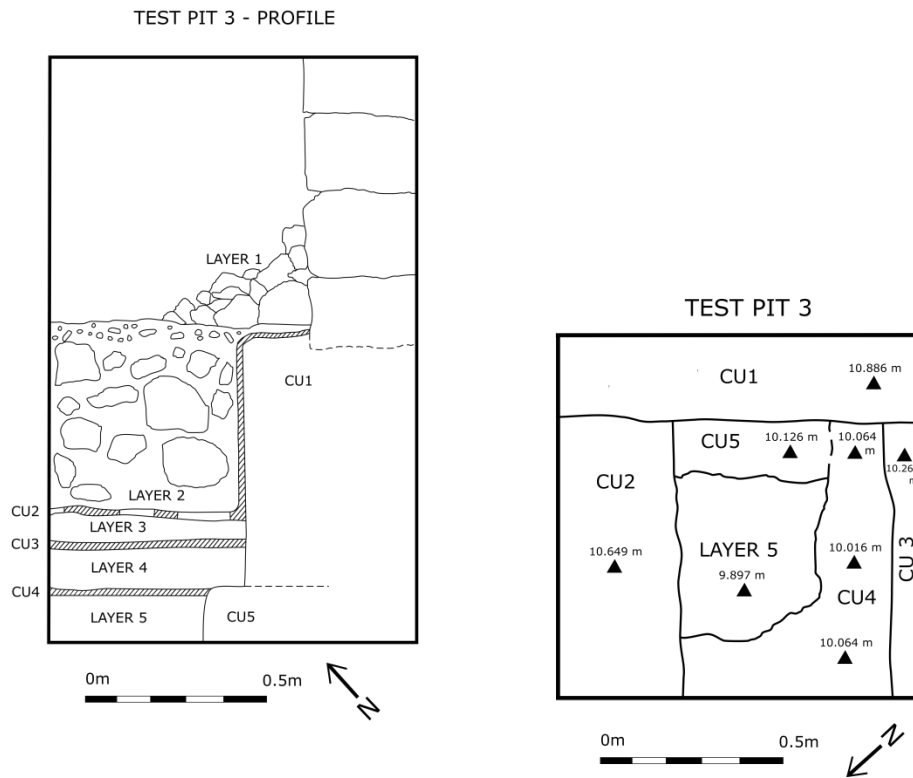
Four layers and 5 construction units were encountered and documented prior to reaching the sterile layer (figure 3).

Figure 3. Section and plan view TP 3.

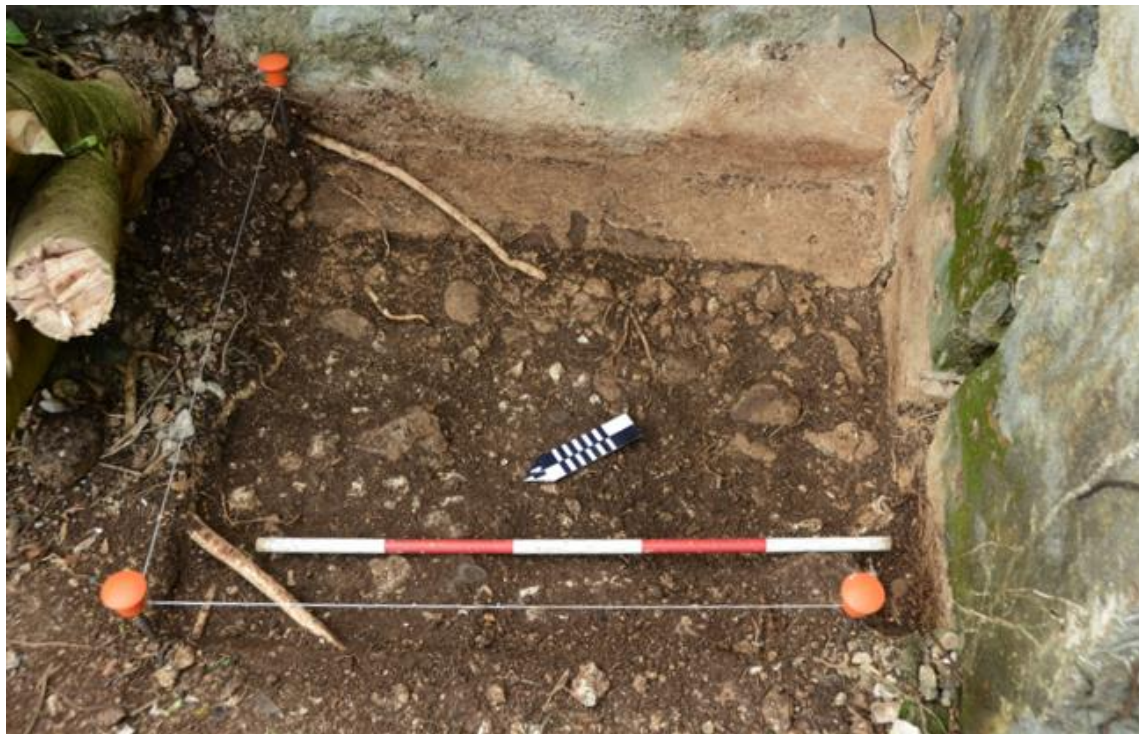
This unit includes a flat surface that was prepared with broken stones; it apparently functioned as a sidewalk (figure 4). It was partially covered by construction unit 4.

Figure 4. Beginning of CU1, covered by CU2.

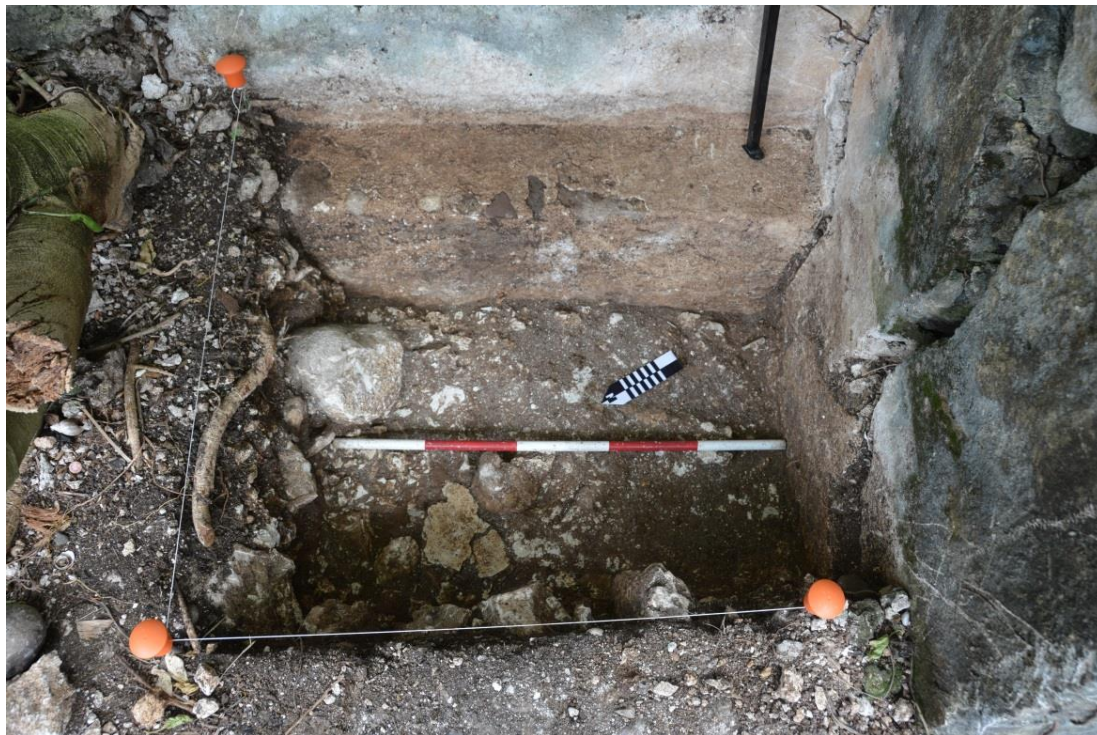
Construction unit 2 (CU2) also serves as a pavement (8/4 2.5 Y) that attaches to CU1, in addition to covering it as a plaster. In the N-W profile, a large well-preserved fragment of this prepared pavement appears, while in the rest of the test pit it only appears a highly fragmented and degraded condition (Figure 5).

Figure 5. Construction Unit 2 (CU2).

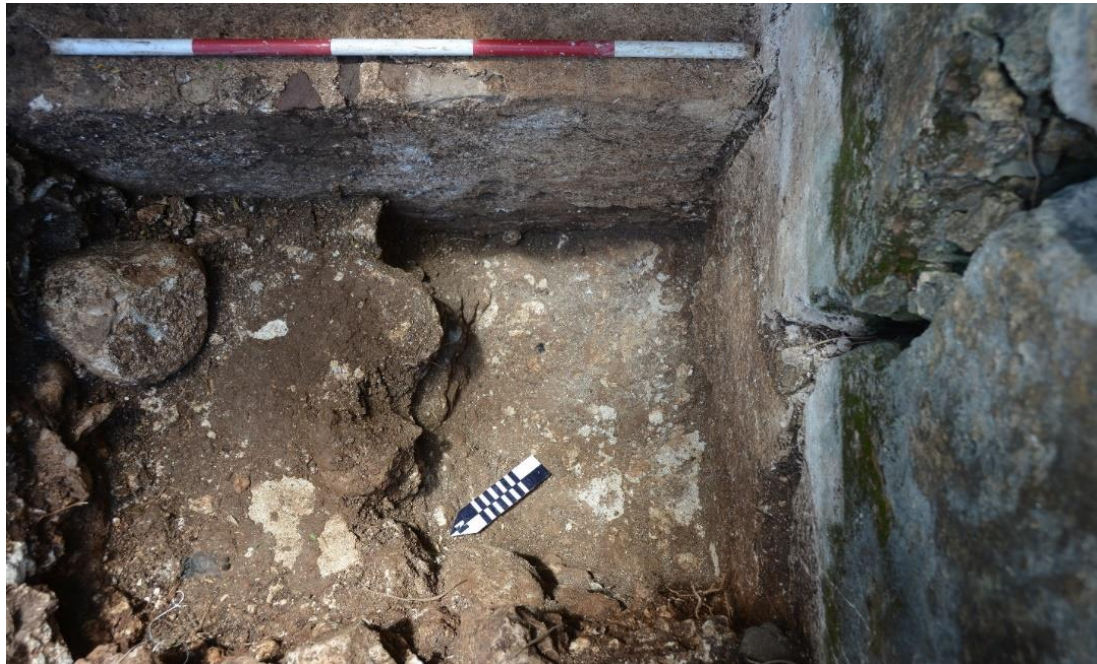
This gray pavement (10YR 6/1) is very degraded, and it is 4.5 cm thick (Figure 6). The pavement contains small fragments of coral.

Figure 6. Pavement CU 3.

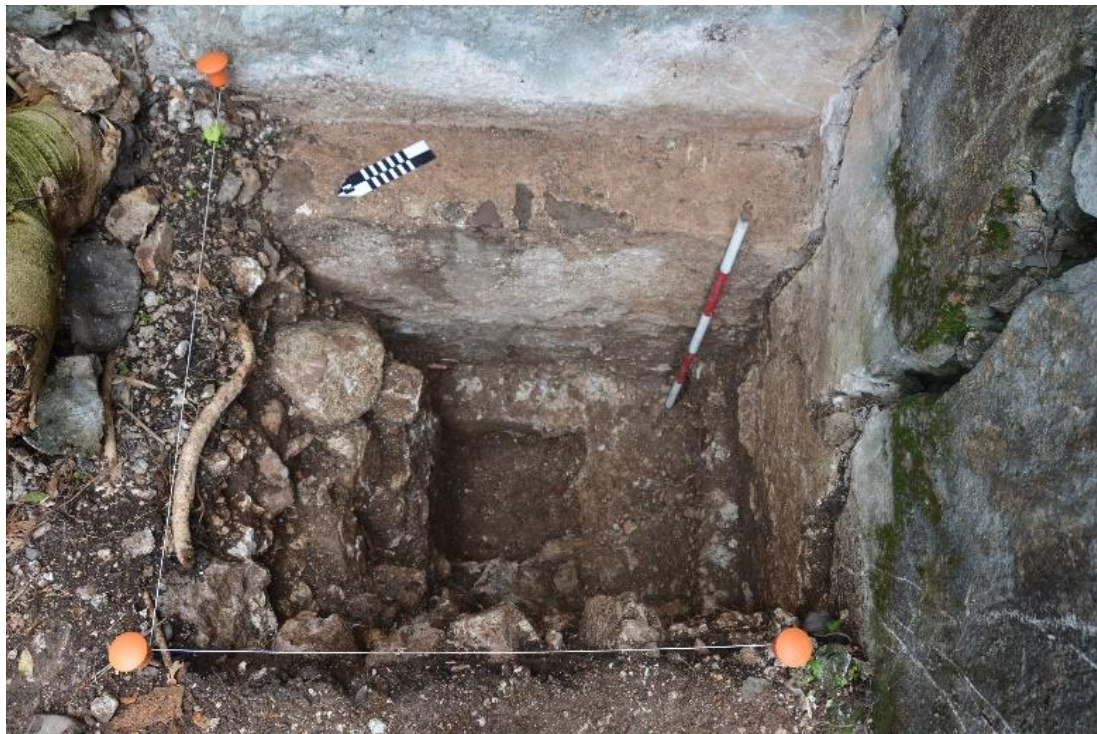
This feature is comprised of coral rocks and a light gray mortar (7/1 10YR) (figure 7). CU1 rests on top of it. Below is the sterile layer and it is 12 cm thick. It is the first foundation of the church.

This layer is comprised of sterile sediments that are dark reddish clay (3/2 5YR) in color. We excavated in only a small area of the unit (figure 7) to preserve this record of the various construction events.

Figure 7. TP3 with its different construction units. The metro bar stays directly over CU5.

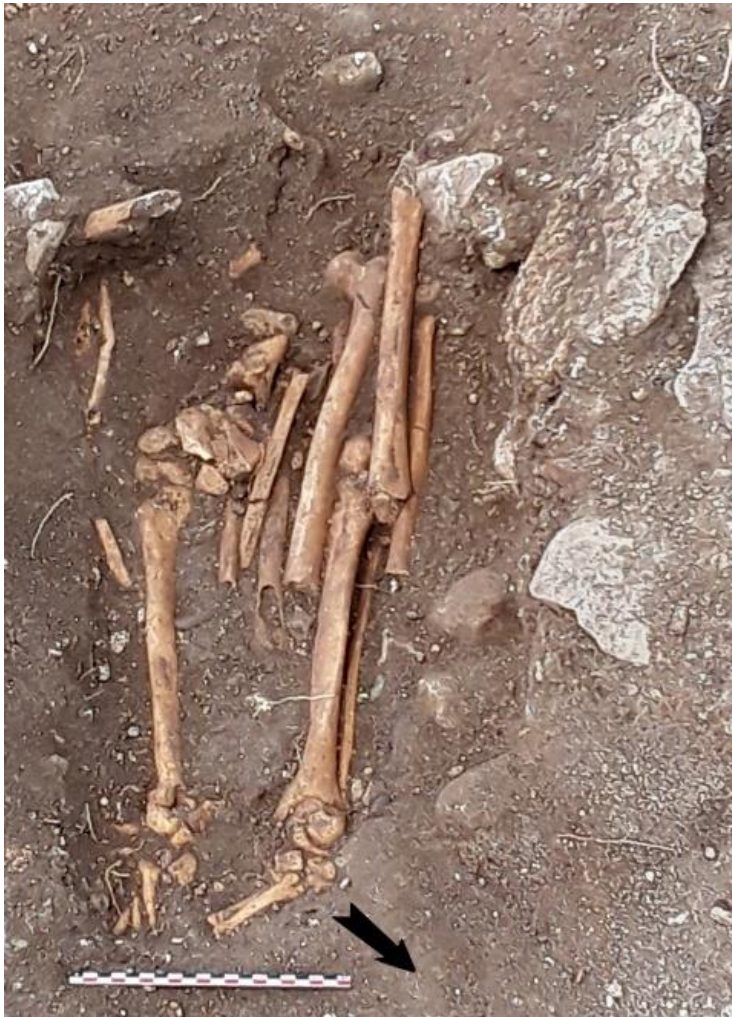
Figure 8. Primary burial 5 and bones set 4 atop.

Burial 5. Adult individual, supine decubitus, found mostly in anatomical articulation and below bones set 4 (figure 8). Orientation S-N.

Bones set 4: Bone remains that mostly correspond to lower limbs that were deposited just above Burial 5, which is a primary burial (Figure 8).

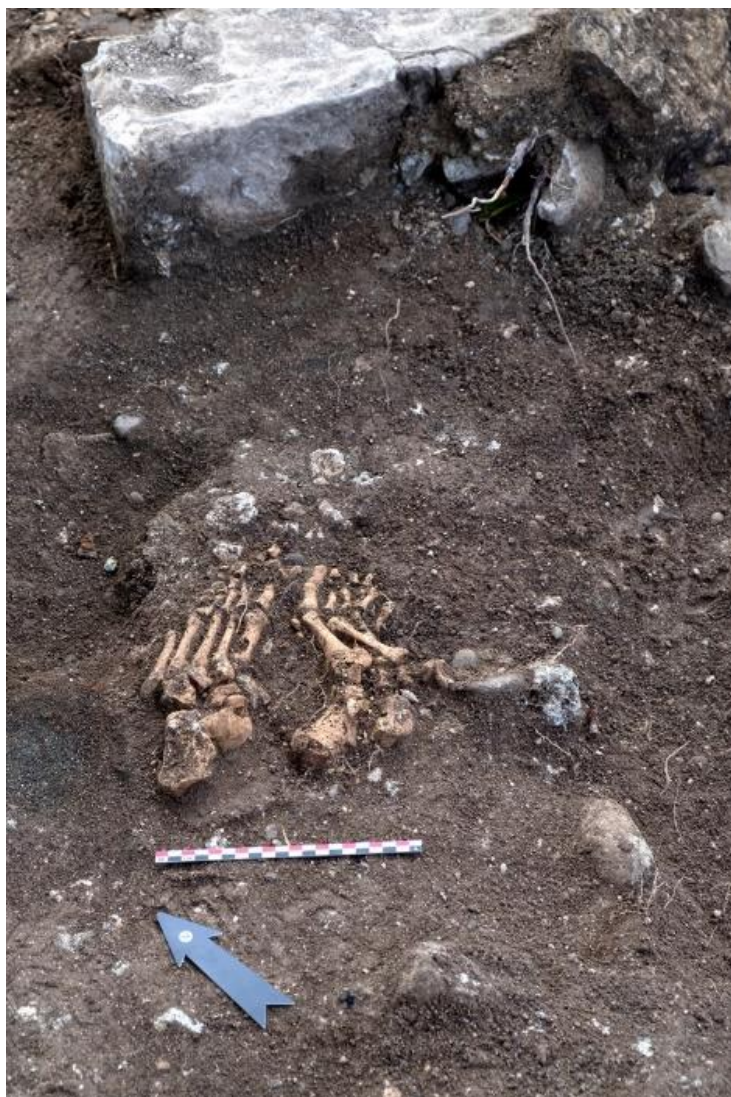
Figure 9. Bones set 5: articulated feet.

Bones set 5: Articulated feet (figure 9). Orientation S-N.

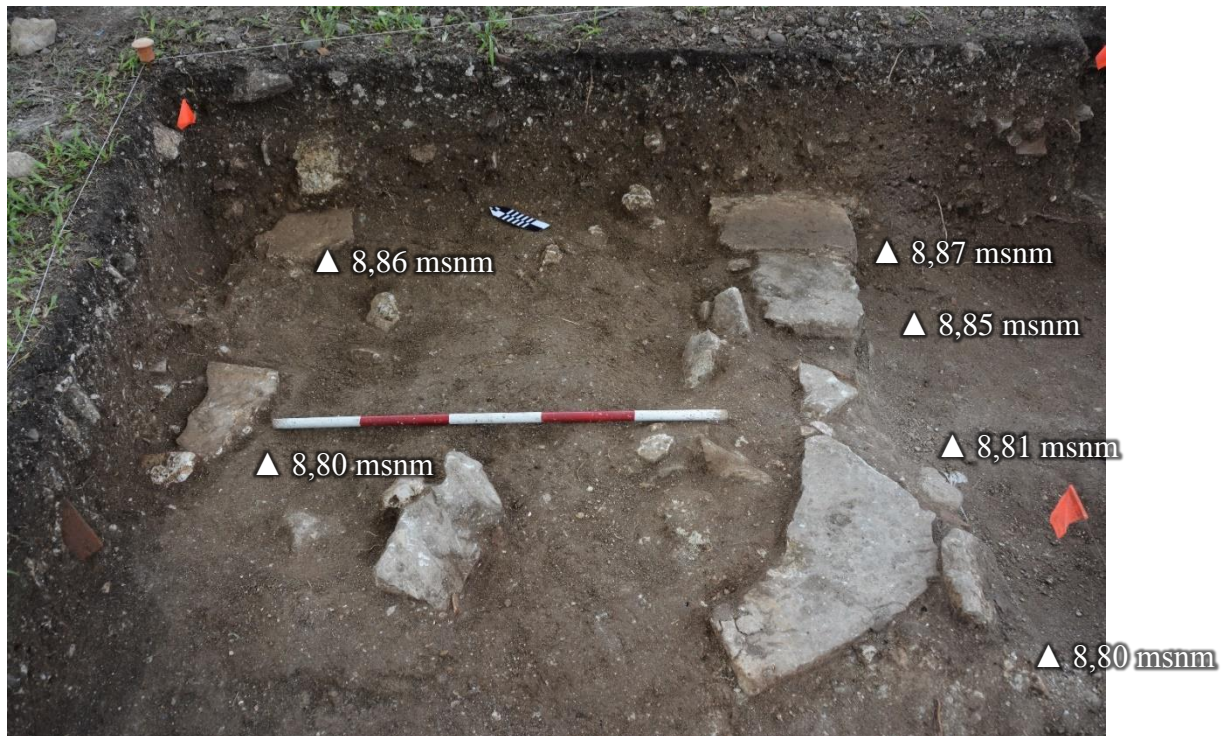
This pavement (figure 10) was originally encountered during excavations during the 2017 season. In the 2018 season we recovered additional stone slabs. Their original placement had apparently been disturbed at some point in the past (i.e., before 2017).

Figure 10. Remains of pavement in Unit 2 (CU1).

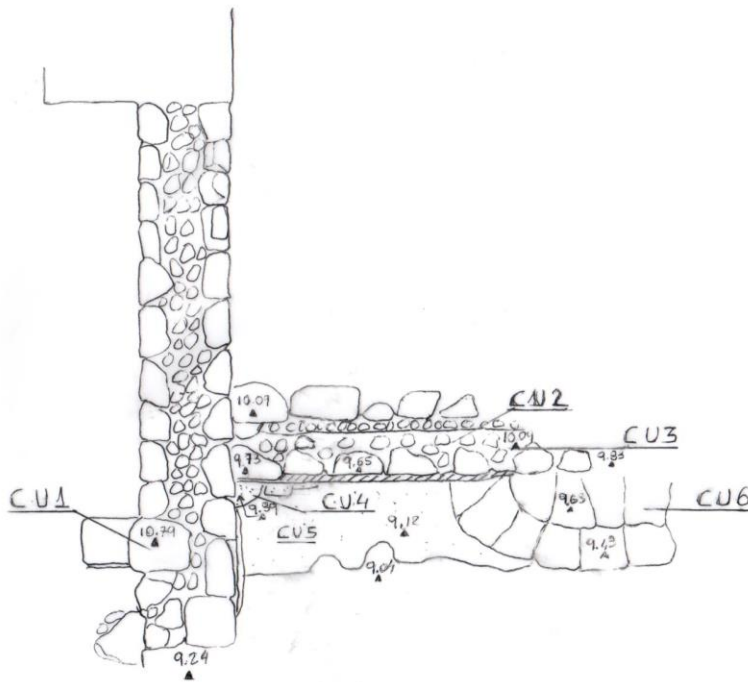
amount of construction features (figure 11) and burials appeared and their temporal relationships warrant further investigation in 2019.

Figura 11. Plan view with different constructive units in UNIT 2 (U2)

This area corresponds to a poorly-preserved floor in the west corner (figure 11). It is also attached to the west wall and the paved sidewalk. If we would theoretically extend this floor, it would be attached to the level of the first step of the access stairway. It is currently covered by layer 3.

This area comprises the main staircase into the church; it consists of three steps (figure 11).

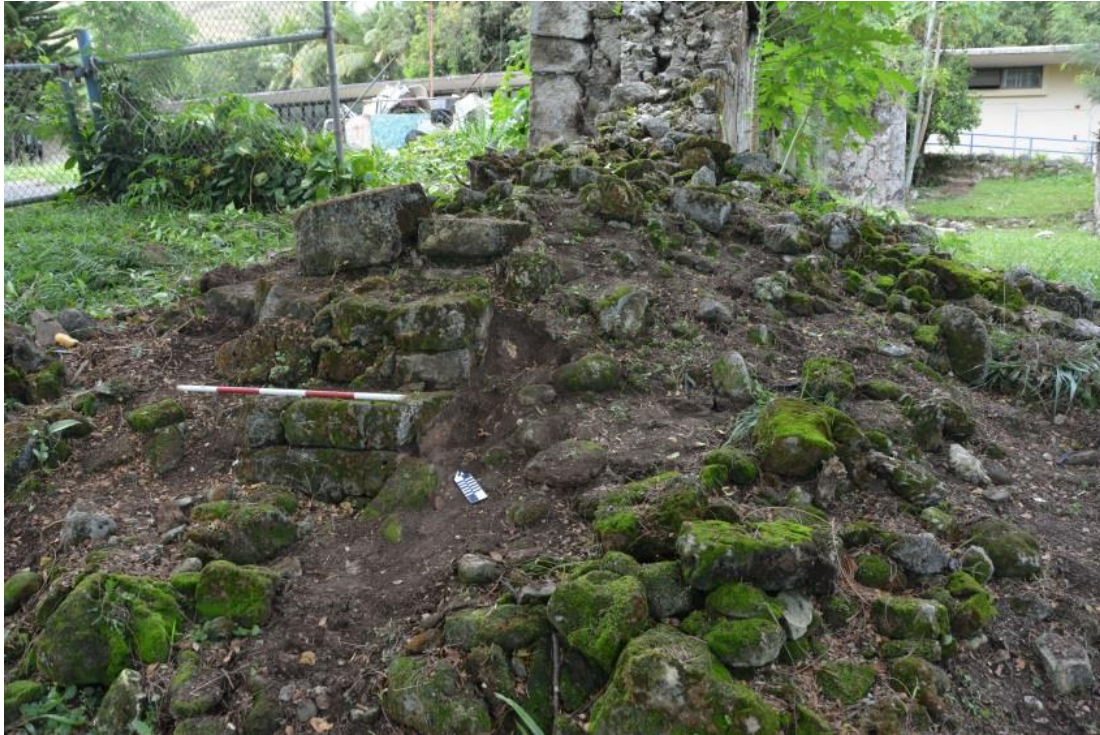
It corresponds to a wall (figure 12) that adjoins to the main façade, and that follows the same orientation to the west wall of the church. This wall limits U3 on its western side. The wall was constructed of stones of regular size with an average of about 0.40 meters to 0.50 x 0.25 to 0.20 meters x 0.20 to 0.15 meters. The stones appear to be from the local area.

Figura 12. Construction unit 1 (CU1) with mortar remains.

Stone collapse. It is higher on the side of the west wall (figure 12) and it slopes downward to ground level along the middle axis of the church at the staircase entrance. Contemporary material culture is present on the surface. Because the volume of stone does not correspond to what should be expected from the collapse of the larger structure, we assume that some of them had been extracted for reuse elsewhere in the Humatak area.

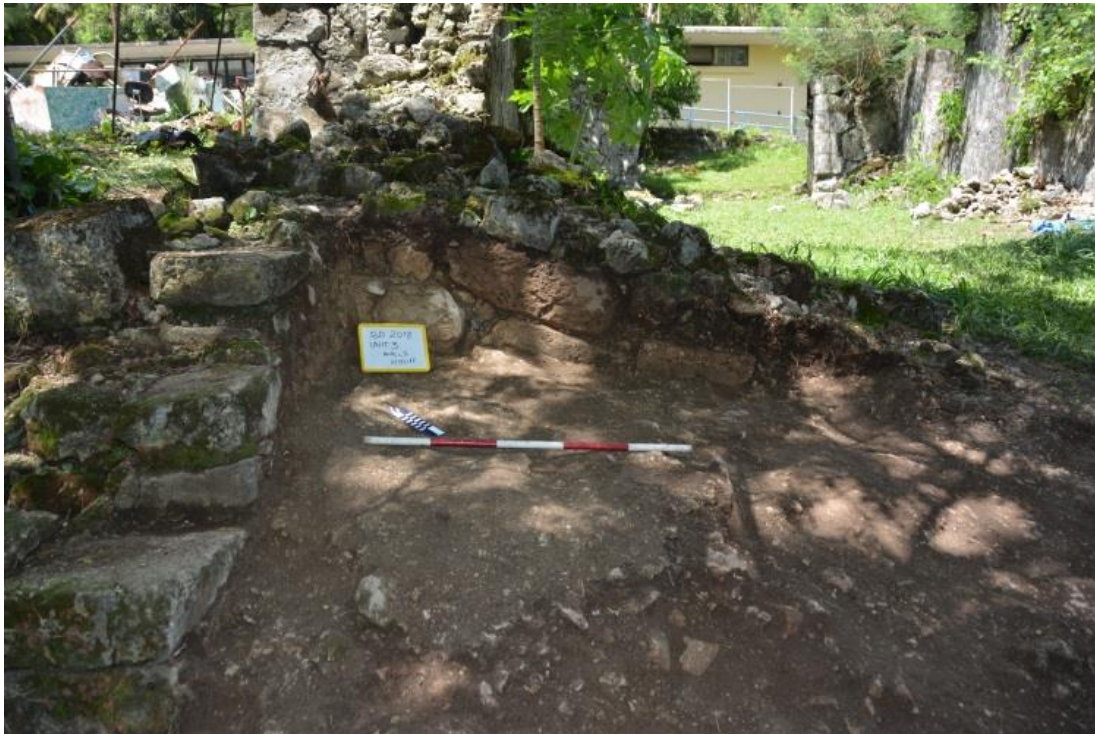
West façade wall (figure 13).

It is very much affected by the collapse and perhaps it was partially dismantled at some point in the past. Its highest level corresponds to the point of contact with the west wall. It follows the slope until it reaches level 2 at 9.63 meters above sea level. Basically, its construction is similar to that of the west wall although with smaller stones and with a matrix that contains a greater amount of mortar.

The main façade is covered by a mortar plaster that is 2-3 cm thick. It is also preserved irregularly and it disappears in certain areas on the wall (figure 13).

Figure 13. Construction Unit 2.

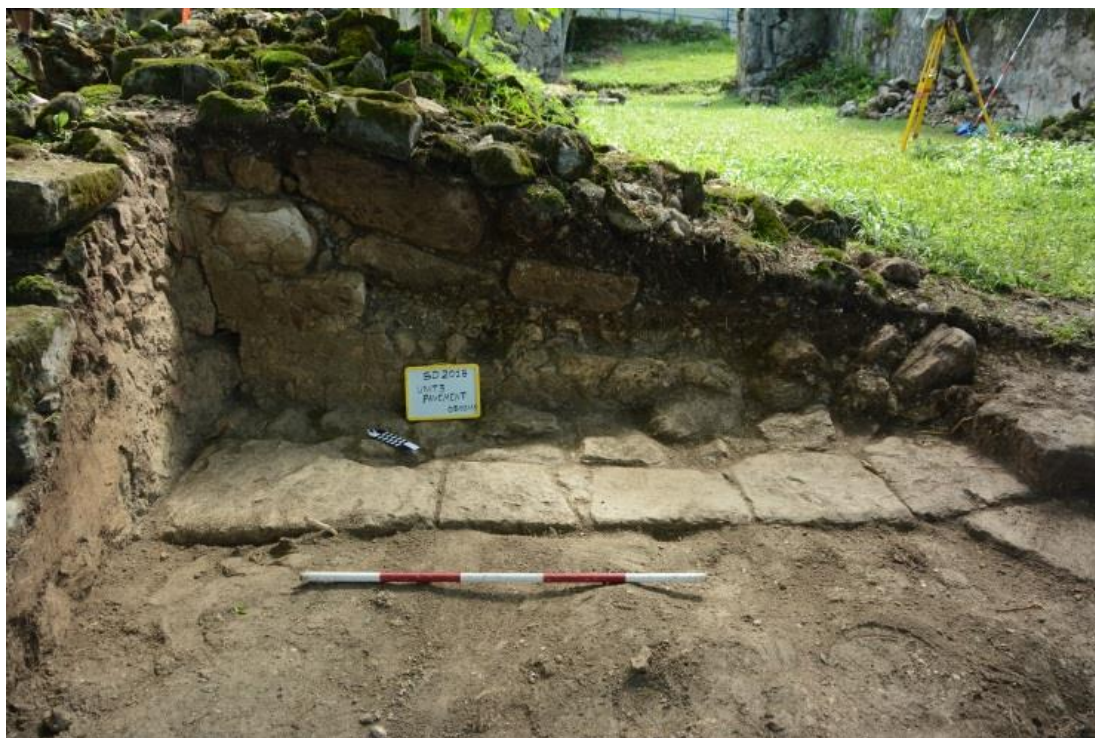
This unit corresponds to a paved sidewalk (figure 14). It is composed of well-crafted and well-arranged stones. There are remains of mortar with which stones were joined. It is not clear if it had some kind of plaster or other finish although some of its fragments were apparently displaced sometime after the pavement was constructed and use. Aesthetically, it is similar to the construction of the wall and its adjoining façade. It may related to an as-yet undocumented structure.

Figure 14. Construction Unit 3 (CU3)

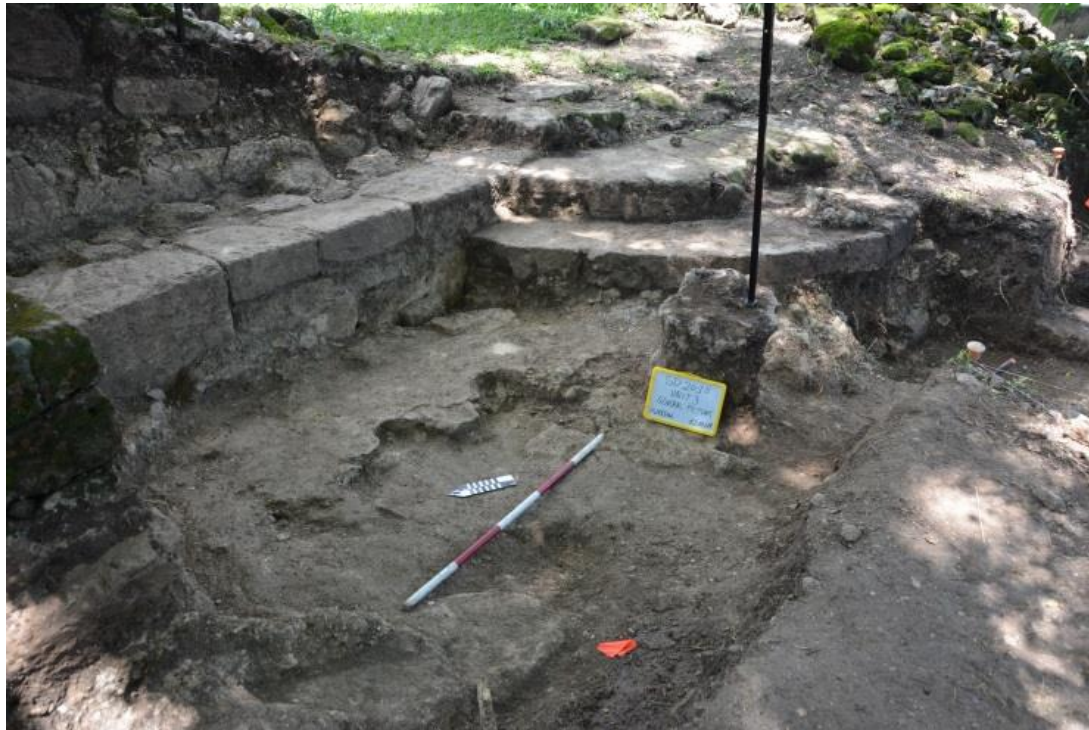
This unit corresponds to a poorly preserved pavement that had been cut (at a later time) to inter burials (figure 15).

Figura 15. Pavement CU5 cut to place burials.

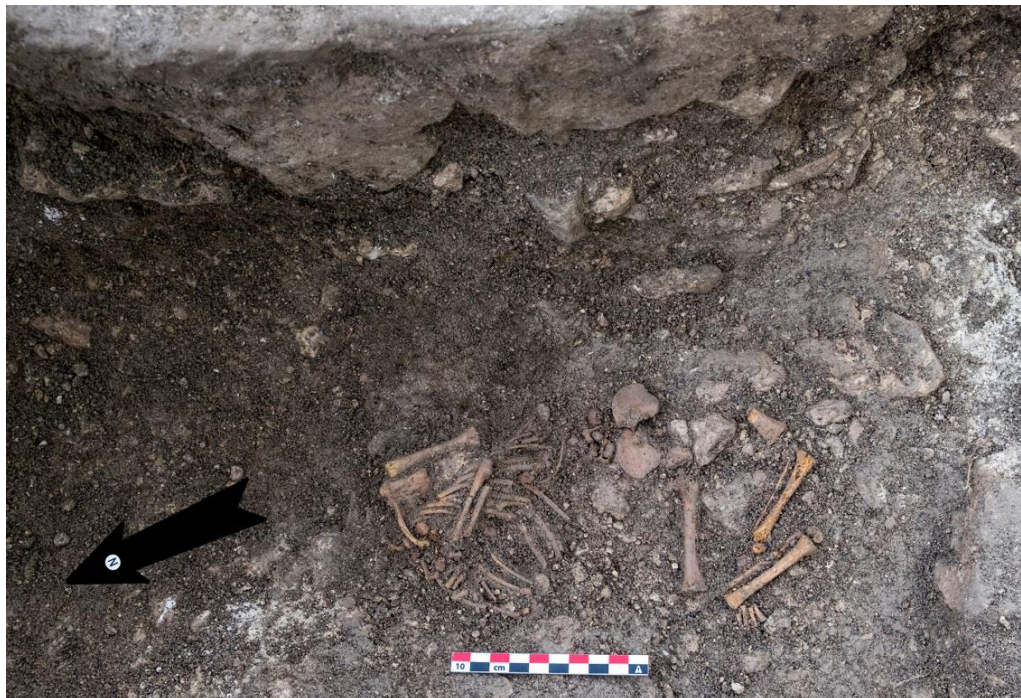
Burial 2. Is a perinatal individual that was buried by the staircase and is close to the facade wall in layer 3 (figure 16). Orientation N-S.

Figure. 16. Burial 2

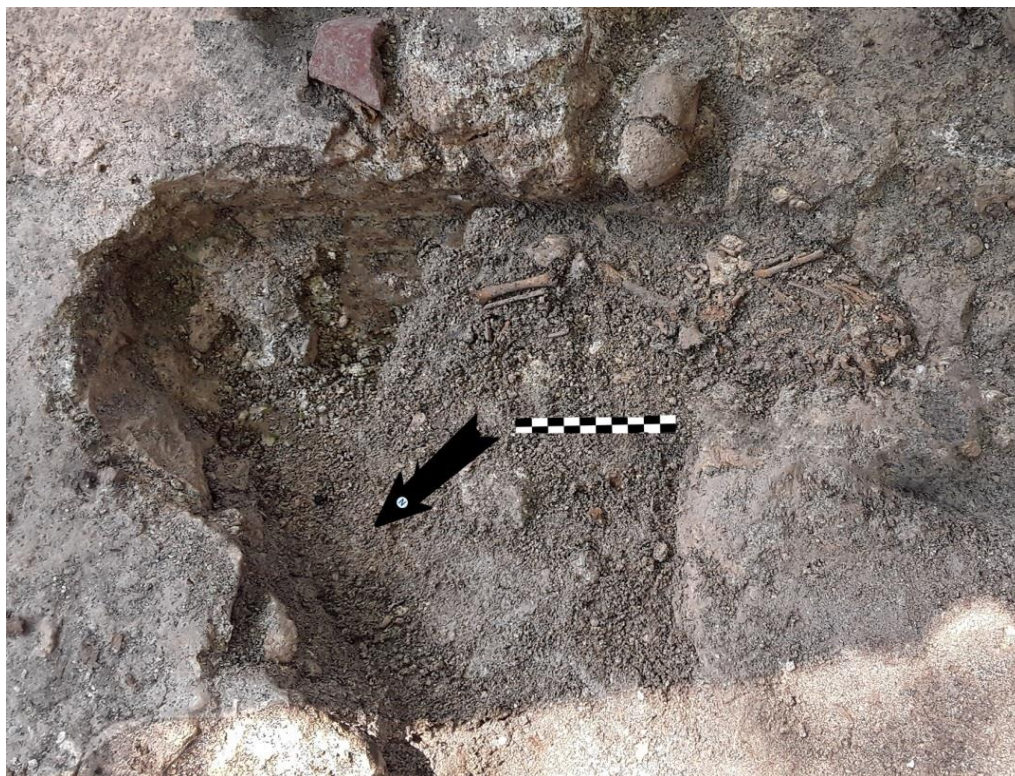
Burial 3. This is a perinatal individual that had been buried in a pit that was excavated in the pavement (figure 17). Orientation S-N.

Figure 17. Burial 3.

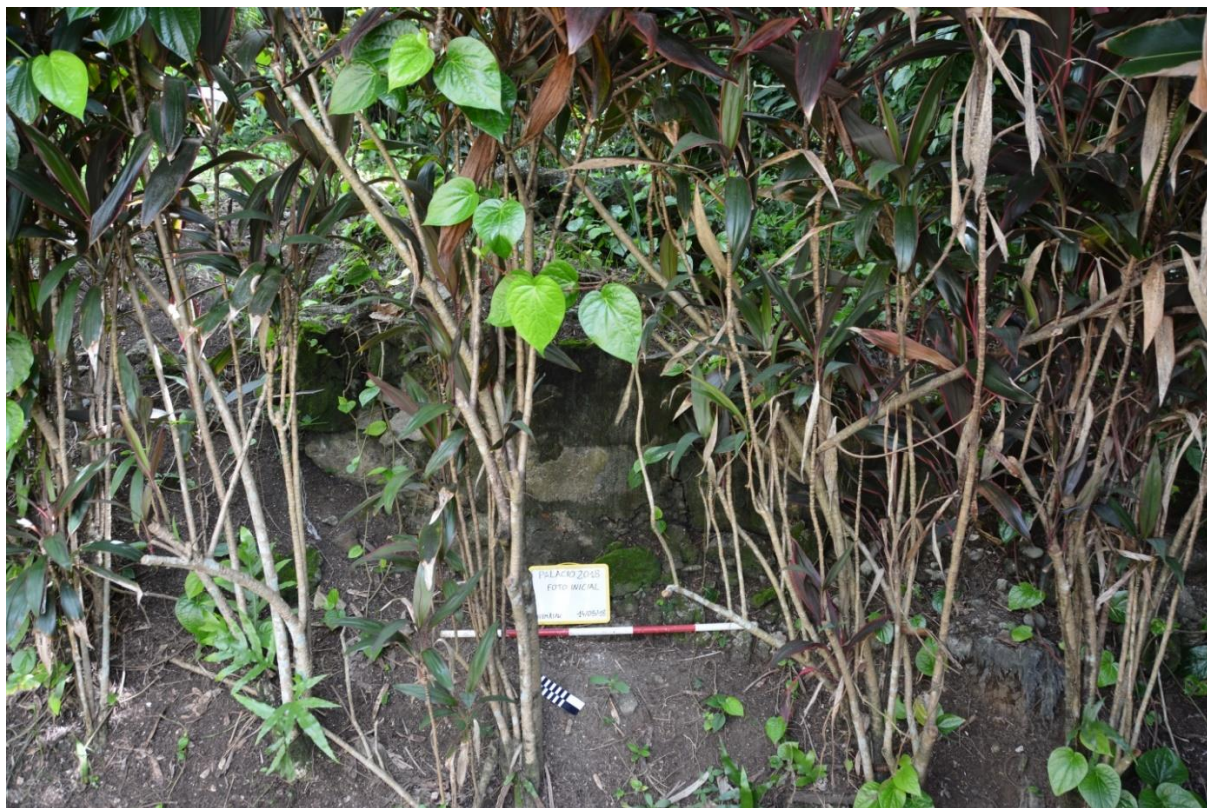
Today, remains of a masonry wall are visible behind the current church of San Dinosio (Figure 19). Therefore, we decided to focus our archaeological work on this area by following this wall (Figure 20).

Fig. 19. Remains of the Wall before 2018 excavation.

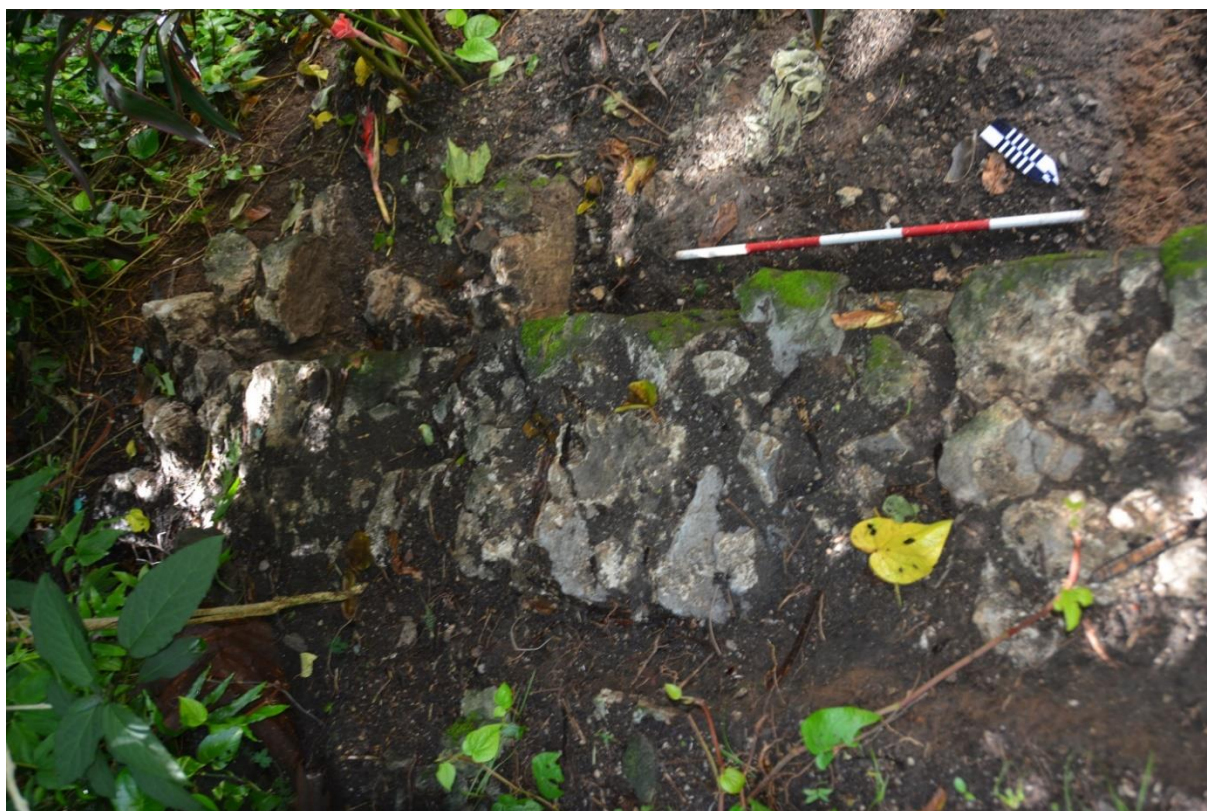
Figure 20. Palasyo's Wall after cleaning.

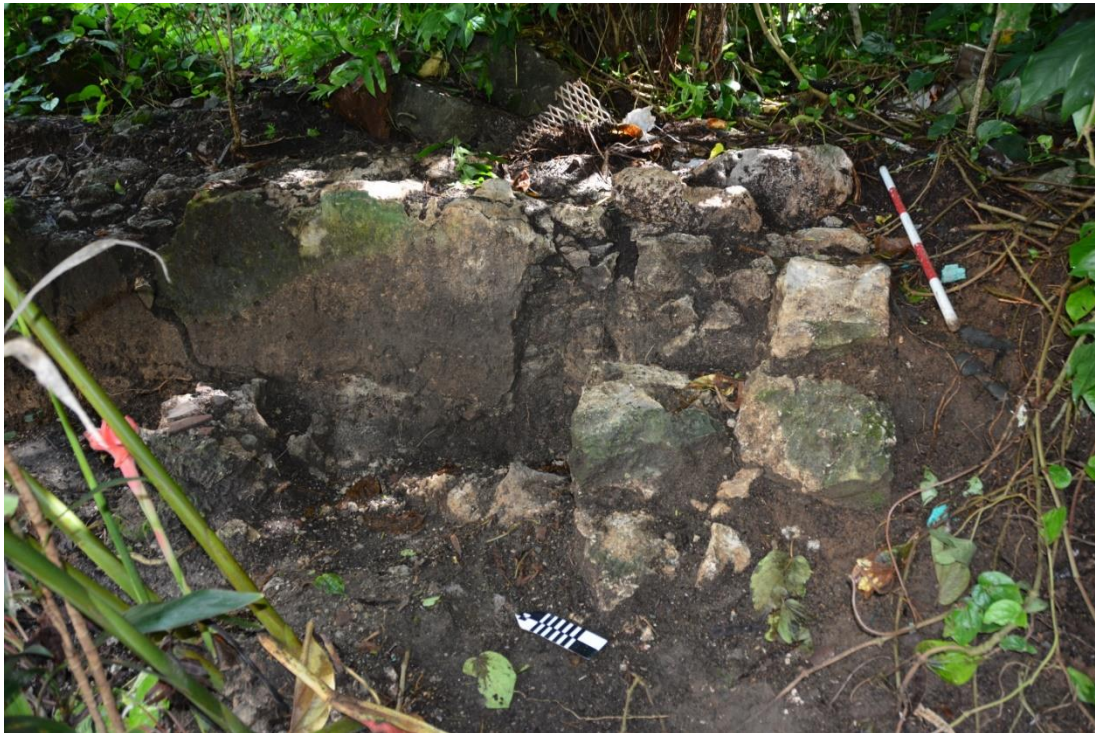
After cleaning the wall to enhance its visibility we were able to document its southeast angle where it turns towards the (figure 21). It remains to be clarified, however, if this closure corresponds to the first or second room of the palace. For this reason, future archaeological work will be necessary in the area immediately behind this wall. However, we already opened a test pit to see if there were intact levels attached to the palace wall. Unfortunately, we found that all the levels had been altered by the construction of the new church of San Dionisio, since modern materials were found up to the point where the wall started. However, we recovered a relatively large assemblage of historical ceramics and porcelains (Figure 22) that are quite different than those at the old church of San Dionisio.

Figura 21. Palasyo's southeast angle.

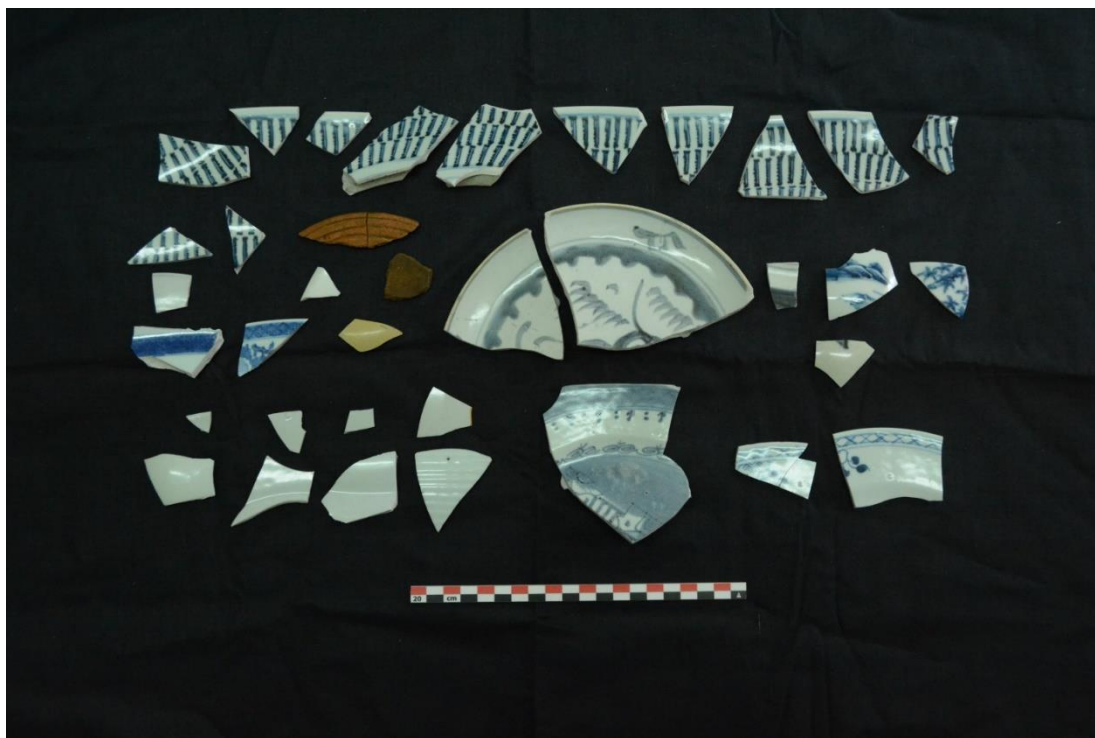
Figure 22. Historicals ceramics from Palasyo.
